Macarena Bustamante-Álvarez &amp; Elena H. Sánchez López

## NEW DATA FROM THE CARTUJA KILN COMPLEX (GRANADA, SPAIN). KILN BEIRO 7

*Partially excavated by Manuel Sotomayor in the second half of the 1960s, Kiln 7 in the Beiro Sector was re-excavated during the most recent interventions at the site. This latest archaeological study has provided new data on the kiln construction process, its structure and its phases of use and abandonment.*

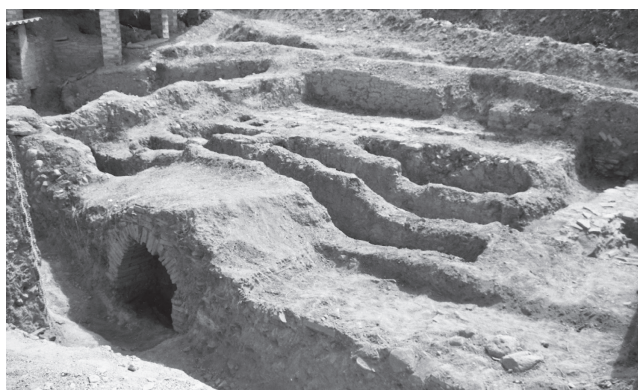
Fig. 2. Condition of Kiln 7 in 1970 (photograph by M. Sotomayor).

The kiln was built using a mixed technique: *opus incertum* of medium-sized river pebbles for the construction of the external skeleton and *opus testaceum* on the central arch that runs throughout the kiln. To these materials we can add the use of mud for the interior lining of the walls that define the entire structure and would have hidden the stone skeleton and adobe for the bracing walls and perforated floor (**Fig. 2**).

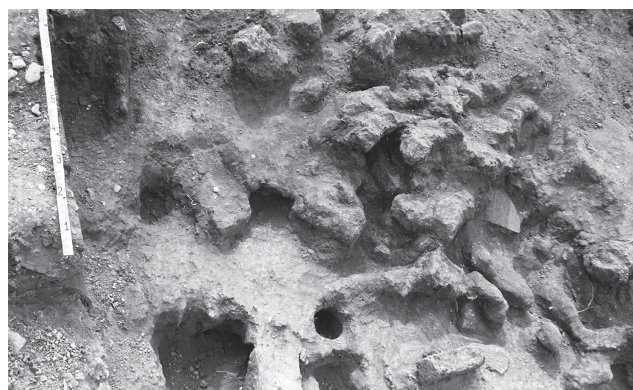
Fig. 3. Adobe bricks fallen on the Kiln 7 grill (photograph by M. Sotomayor).

What we are unable to provide any information about is its covering, a factor we could also extrapolate to any possible nozzles and chimney flues. It was the study undertaken by Sotomayor (1970: 721) that highlighted that the structure was very superficial at the time of its discovery, a circumstance that affected the conservation of the elevations of the kiln firing chamber. However, the photographs taken during the excavation process show the discovery of adobe remains fallen on the grill, indicating that either the roof, the chamber walls, or perhaps both, had been made of that material (Fig. 3).

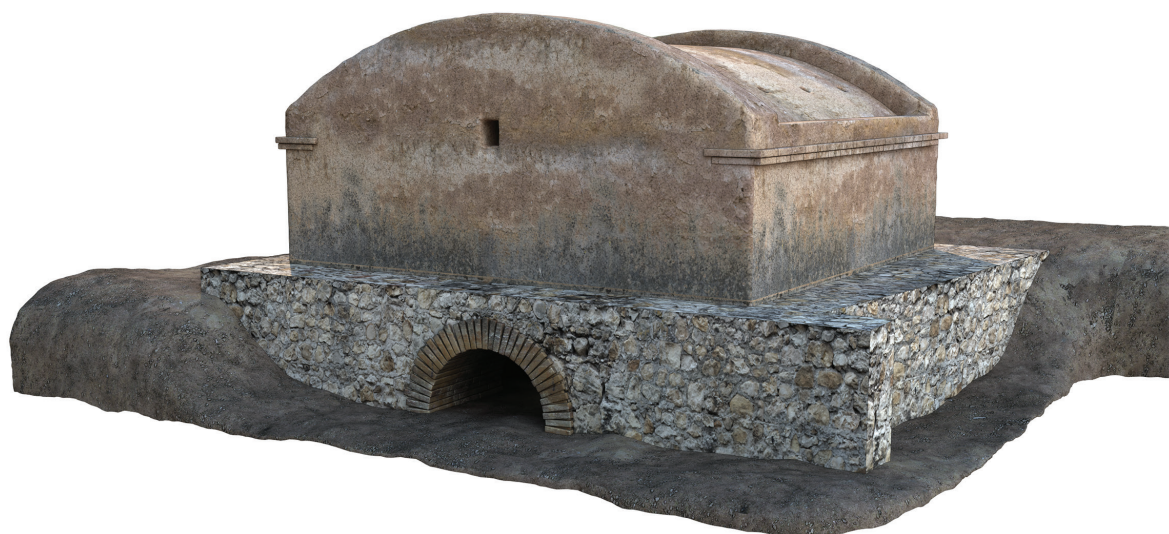
Fig. 4. 3D reconstruction proposal for Kiln 7 (made by Balawat).

Based on the results of the Kiln 7 excavations, a 3D reconstruction has been proposed, at least in what is considered to be its first construction phase. However, while the elements that composed the structure up to the level of the grill and the bottom of the firing chamber walls seem clear (as described above) and allow a fairly definitive reconstruction, the information relative to the closure is very poor and only allows hypotheses to be put forward.

the hypotheses proposed the existence of a vaulted roof, as found in most of the proposals in the bibliography, or a domed roof, as proposed for the Port-la-Nautique kiln.

The calculations<sup>3</sup> showed that a solution similar to that proposed for Narbonne did not fit the thickness of the walls of the Granada kiln, forcing the generation of a complex roof that used the technical resource of pendentives. On the other hand, the use of a lowered barrel vault, similar to that proposed in most of the proposals found in recent historiography, adapted better to the structure's measurements and characteristics (Fig. 4).
