## A new topographic survey of the walls of Pompeii: Porta Nola from 3D laser scanner to conservation problems

*Since 2016, within a broad collaboration agreement between the Archaeological Park of Pompeii and the University of Bologna, a new scientific research project started, with the aim to study and document the north-east sector of the walls of Pompeii, included between Porta Vesuvio and Porta Sarno. The first accomplished result was to achieve a new documentation using protocols and procedures inspired by those used by the Plan of Knowledge of the Great Pompeii Project. Within the new research, while complying with the original guidelines, we tried to update some procedures regarding the analysis of the deterioration and to propose new research lines. The works are ongoing thus we present here the first remarks and an illustrative case focused on the context of Porta Nola.*

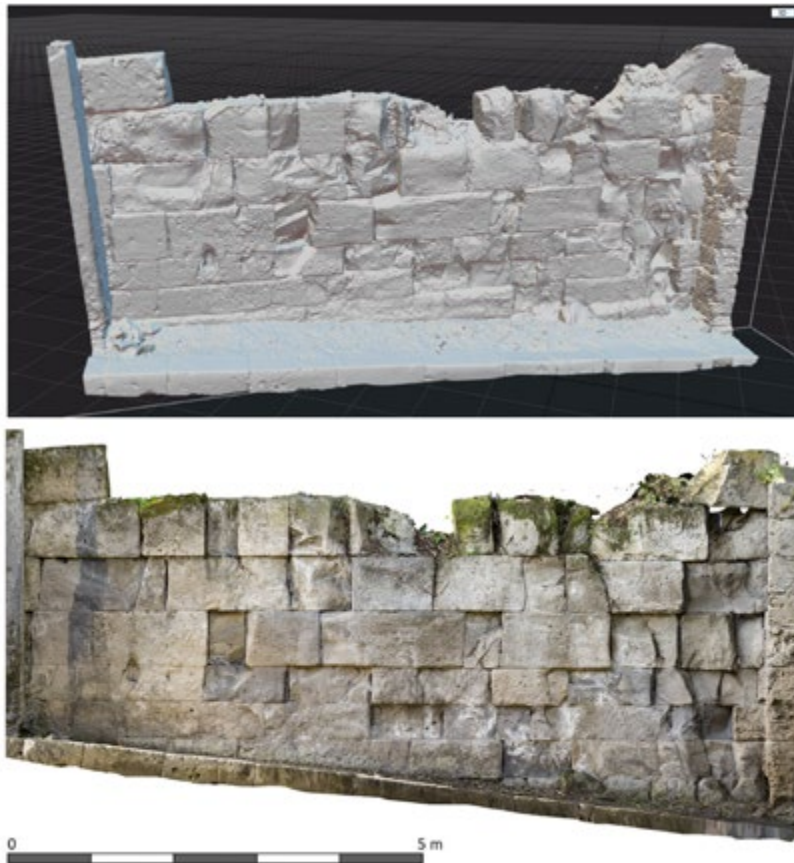
Fig. 6. Three-dimensional model of the surfaces (Digital Surface Model) and their relative orthophoto

At the same time, the innate potential of the laser scanner survey was taken advantage of to create three dimensional models through the process of modeling the surfaces (mesh) and for the extraction of orthophotos (Fig. 6). The last aim, which is being carried out now, is the creation of a single three dimensional database which can recognize the informational systems already being used and

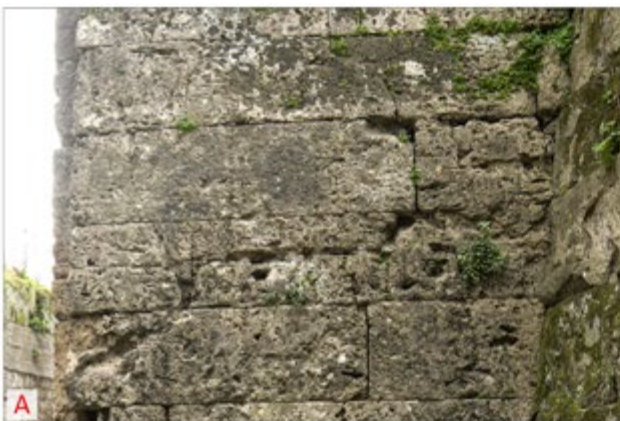
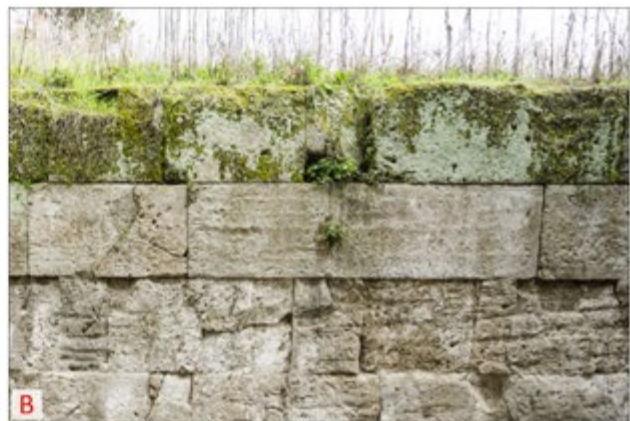
*Fig. 11. Evaluation of the intensity of the phenomenon of biological colonization on the stone surface. Image A: Wall surface of the Left Bastion of Porta Nola. Image B: wall surface of the section between Porta Nola and the left Bastion*

It has been observed, for example, the appearance of the phenomenon of biological colonization on various wall surfaces (Fig. 11): the surface facing North of the left bastion of Porta Nola (Fig. 11a) shows this form of alteration which is widespread on almost all the squared ashlar; the surface of the section of walls between Porta Nola and the left Bastion (Fig. 11b) shows a relevant intensity of the phenomenon on the summit ashlar (more exposed to meteorological events) and it is such that it should be considered deterioration, while a lesser intensity on the lower ashlar can be described as an alteration.

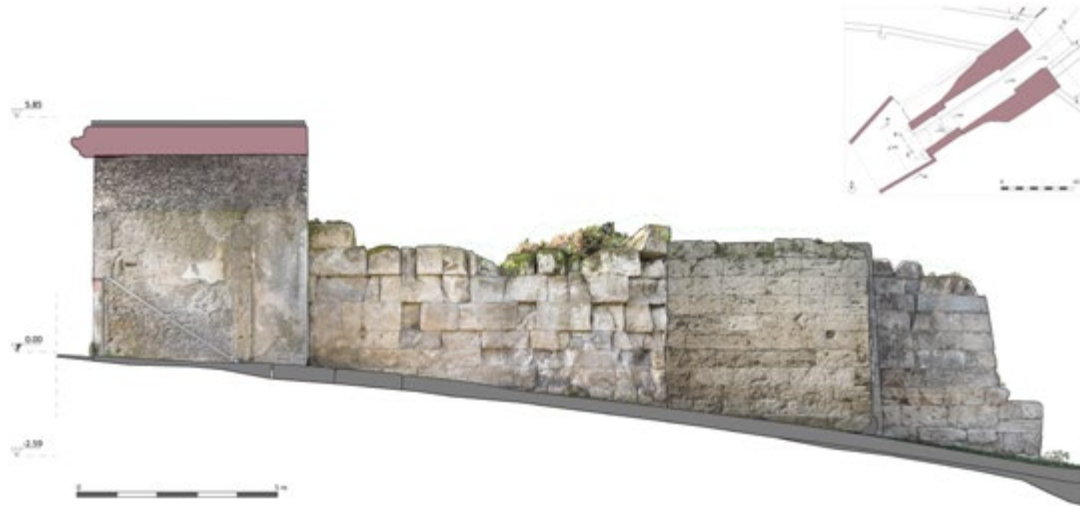
Fig. 13. Porta Nola, longitudinal section. Photomap created in September 2017

Porta Nola represents an important case. We compared the wall structures in their state of deterioration investigated in September 2017 (Fig. 13) with what was described by Mazois in 1812 (Fig. 14) and what was presented by Maiuri in 1930 (Fig. 15).

From the investigation of the deterioration done in September 2017, there are some forms of alteration in an advanced state and forms of deterioration which are very advanced, including alveolarization, disintegration and detachment of stone material,

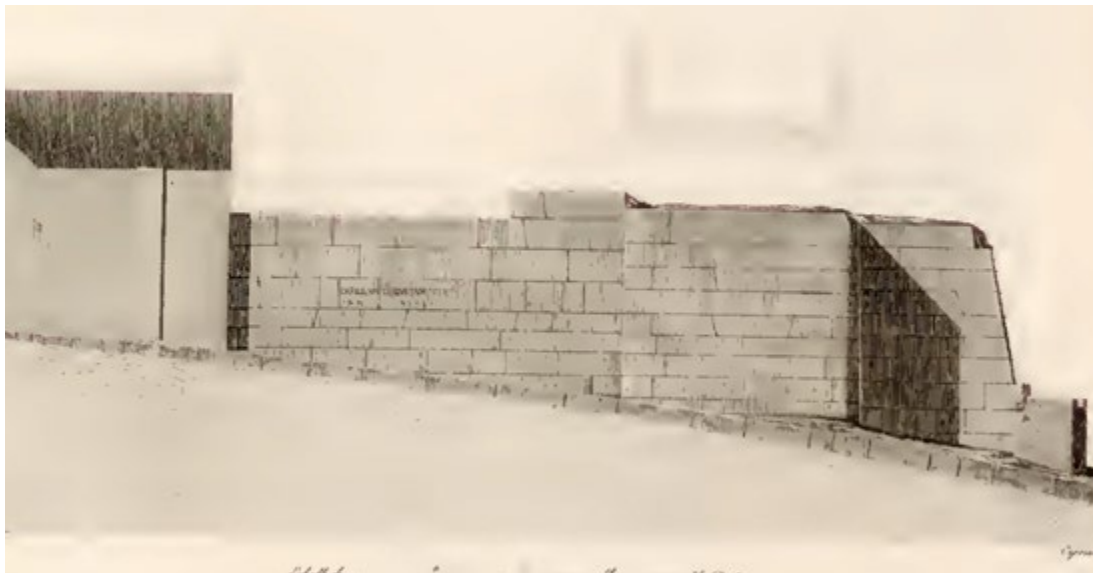
Fig. 14. Porta Nola, longitudinal section, Mazois, 1812, Tav. XXXII

The section of Porta Nola depicted by Mazois does not describe the beginning of cracks in the wall facing. In this case, it can be assumed that this phenomenon, today very evident, occurred after that date. It is necessary, however, to reflect on the reliability of the source. Mazois, in fact, in depicting Porta Nola, made a few errors in the planimetry.

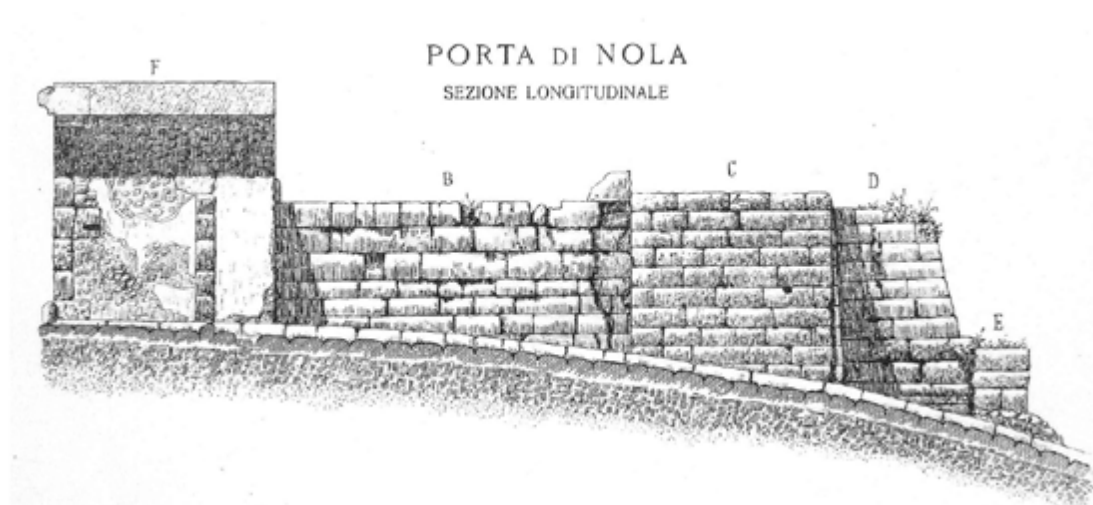
Fig. 15. Porta Nola, longitudinal section by Maiuri, 1930, Tav. XI

for rain runoff<sup>47</sup> the crack in the wall facing is a deep break which goes up almost vertically (Fig. 15-16).

A little more than a century later, Maiuri carried out the material survey of Porta Nola with great precision. The squared ashlar of the wall can be seen as well as the plastered sections of the arch of the gateway, the forms of deterioration. The missing materials, the cracking of the blocks and the deep breaks along the joints are already evident.

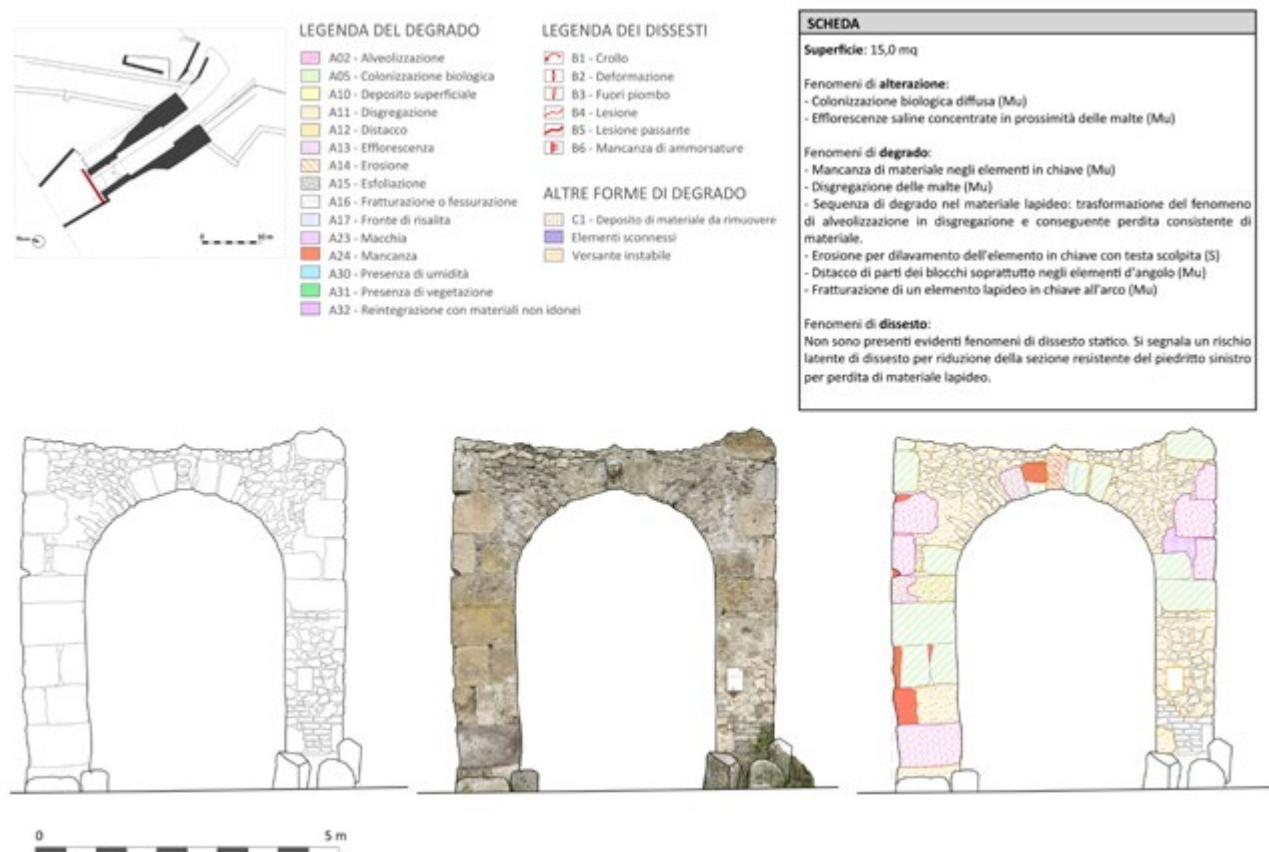
Fig. 20. Reading of the conservation state of the architectonic surfaces depicted in the internal perspective of the macro-element of Porta Nola. Surface P X 4 P 4 O

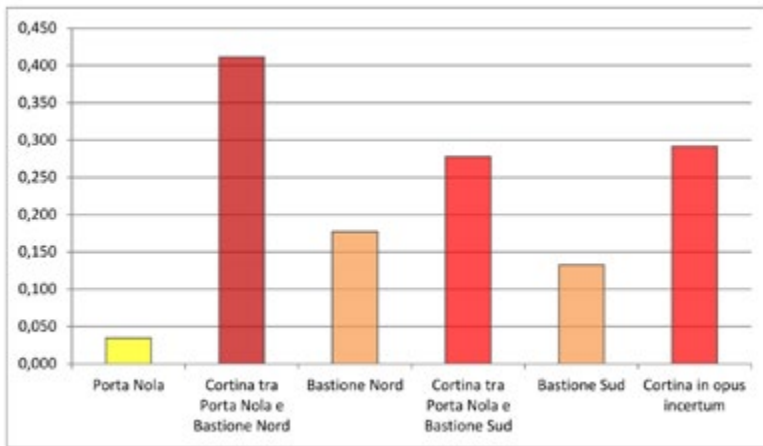
Fig. 25. Chart of the risk indices of the macro-elements making up Porta Nola.
